Arapuni Dam, Waikato River, New Zealand

THE DAM

Built in the 1920s, the dam is a 64m high curved concrete gravity dam with a crest length of 94m.

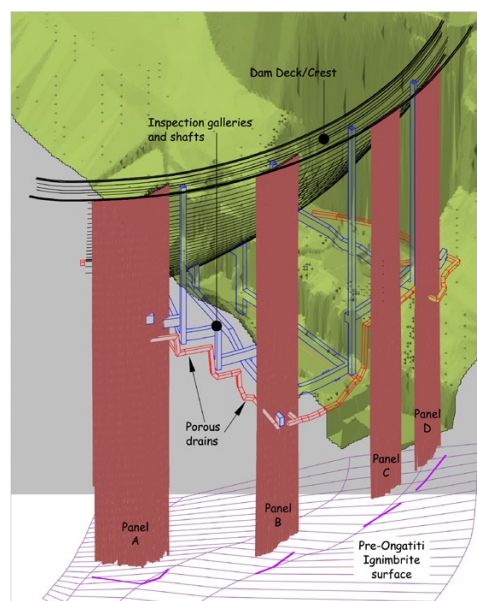
Construction of the four overlapping bored pile walls at Arapuni Dam consisted of 400mm diameter holes drilled at 350mm centres while the reservoir remained full. The 95m deep holes from the dam crest extend through the concrete dam and 40 to 60m into the vertically jointed ignimbrite. The cutoff wall was constructed in discrete segments to limit the construction induced tensile stresses on the unreinforced upstream face of the dam and avoid collapse of the weak foundation rock.
