BACKGROUND

The Pukaki Canal Intake is a reinforced concrete culvert and transition basin owned by Meridian Energy that controls the discharge from Lake Pukaki and is the primary feed to the chain of six hydro power stations, with a generating capacity of 1550MW, on the upper and mid Waitaki Valley.

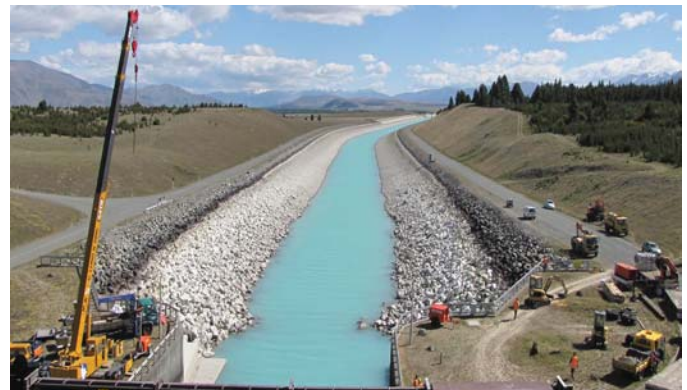
was removed from service, repaired and reinstated in 6 days, with no impact on consumers. The canal was safely dewatered, reinforced and silica fume concrete placed over the damaged slab and shotcrete on the sloping faces. The canal was recommissioned after 62 hours work with no impact on electricity consumers.
